**HEBRON TOWN COUNCIL
HEBRON UTILITY REGULATORY COMMISSION
MINUTES OF JANUARY 23, 2024**

On October 9, 2023, Dixon Engineering Inc. performed a maintenance inspection on the 100,000 gallon double ellipse (South) elevated water storage tank owned by the Town of Hebron, Indiana. Purposes of the inspection were to evaluate the interior and exterior coating's performance and life expectancy, assess the condition of metal surfaces and appurtenances, review safety and health aspects, and make budgetary recommendations for continued maintenance of the tank. The inspection was performed from existing ladders and platforms with no special rigging and no disassembly of any items was conducted by the inspector. All recommendations with budgeting estimates for repairs are incorporated in this report.

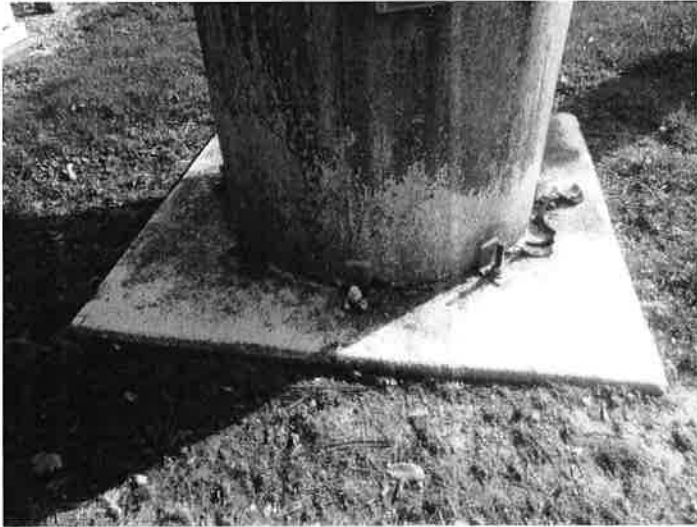
1) The concrete riser foundation is in good condition with no significant deterioration.

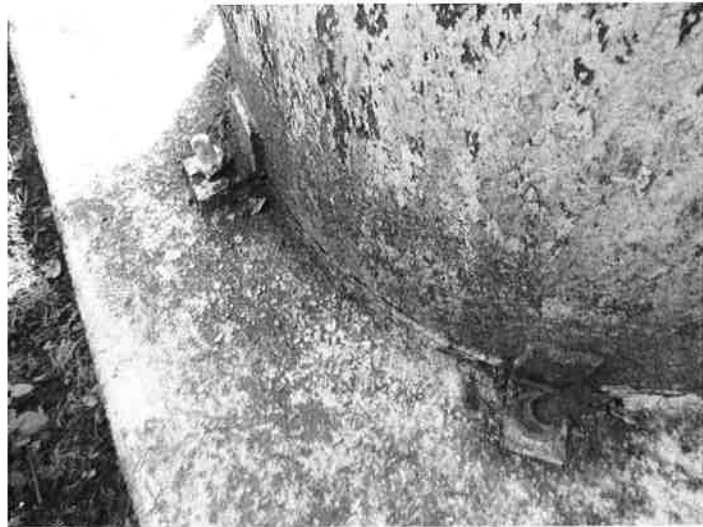
2) The grout between the steel baseplate and the concrete foundation on the riser is intact.

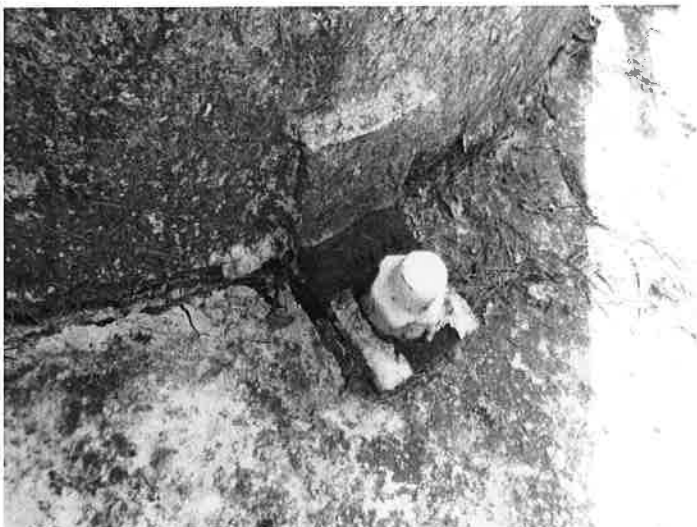
3) The riser anchor bolts are in good condition.

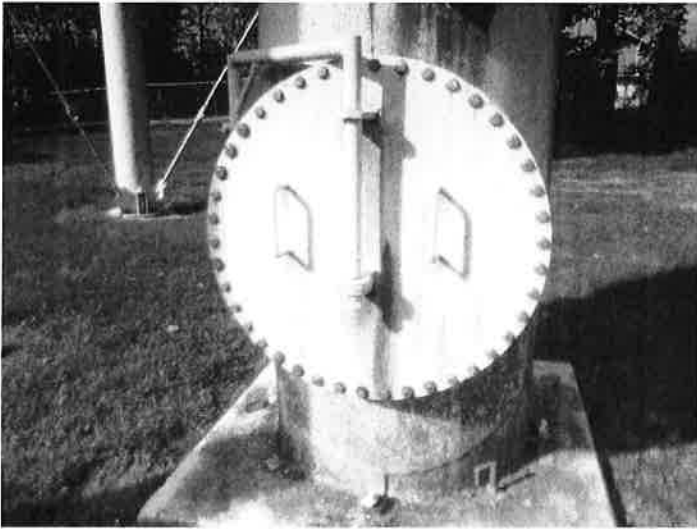
4) The riser manway is in good condition.

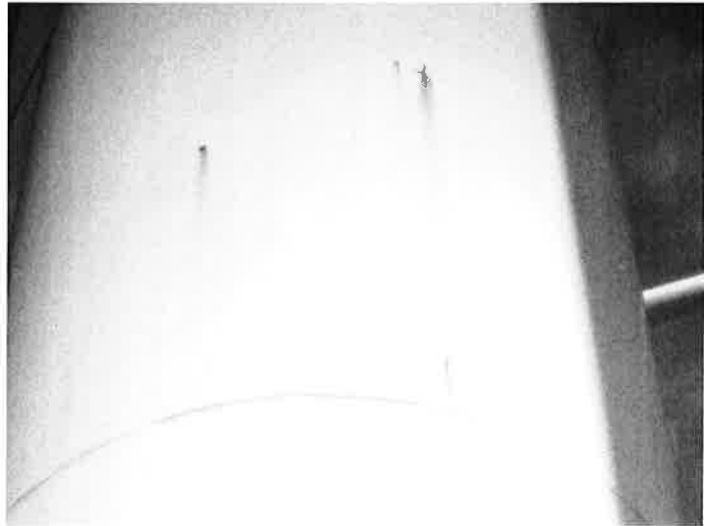
The riser and leg coating are in fair condition with a few failures. Primary methods of deterioration are spot failures to the substrate with rust undercutting and erosion.

5) There are a few coating failures on the riser.

The recommended procedure is to high pressure water clean (5,000-10,000 psi) the exterior to remove any poorly adhered coating and any contaminants. Coating failures to the substrate would be spot power tool cleaned to a bare metal (SSPC-SP11) condition. All sharp edges would be feathered into the surrounding coating.

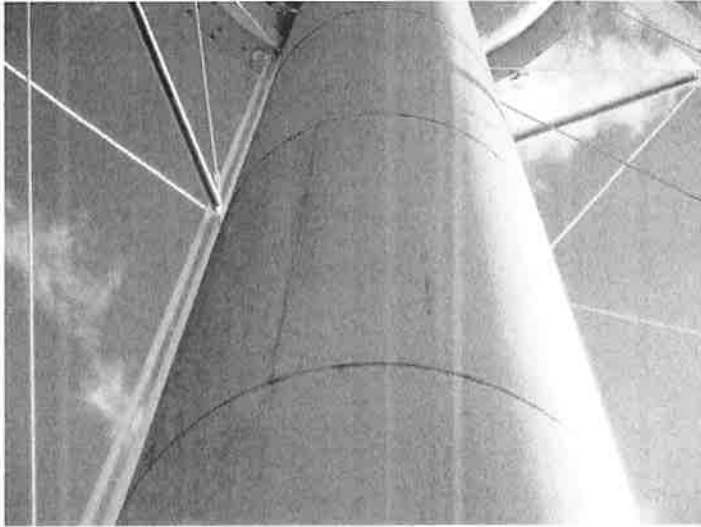
7) The riser coating is in fair condition overall.

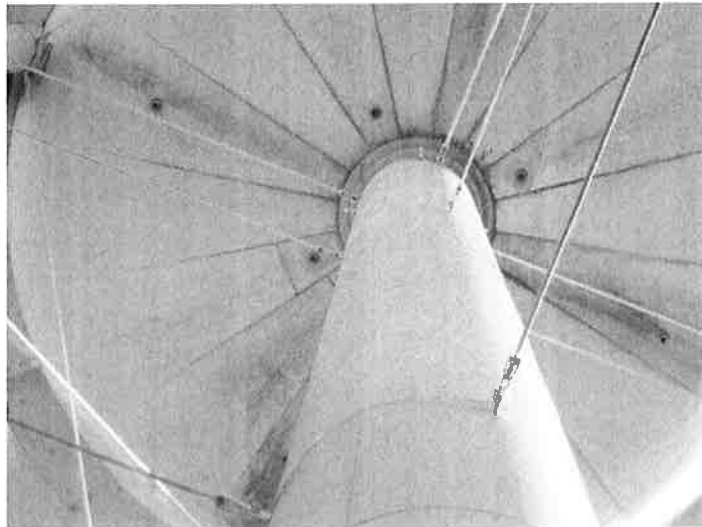
8) The riser tie rods are in good condition.

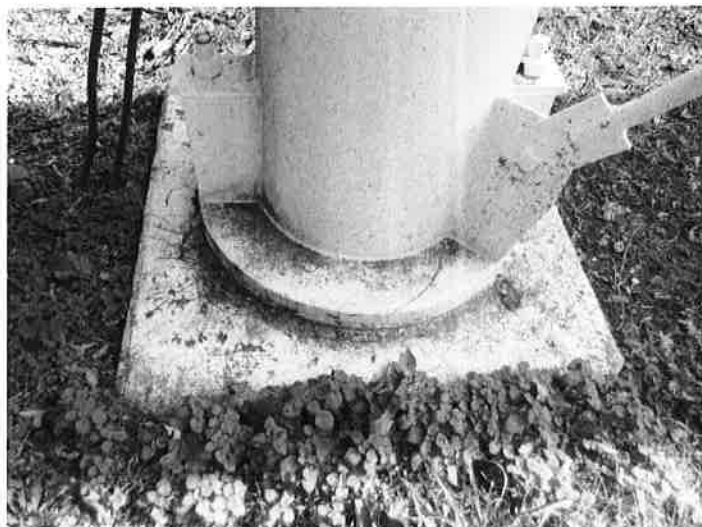
9) The concrete leg foundations are in good condition with no significant deterioration.

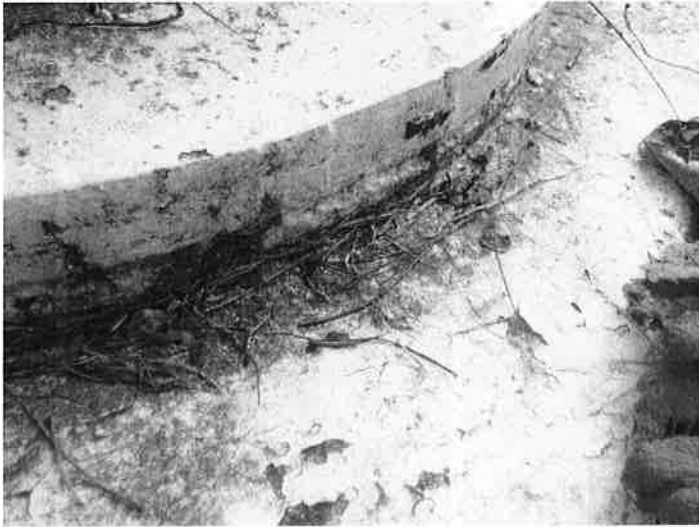
10) The grout between the steel leg baseplates and concrete foundations is intact.

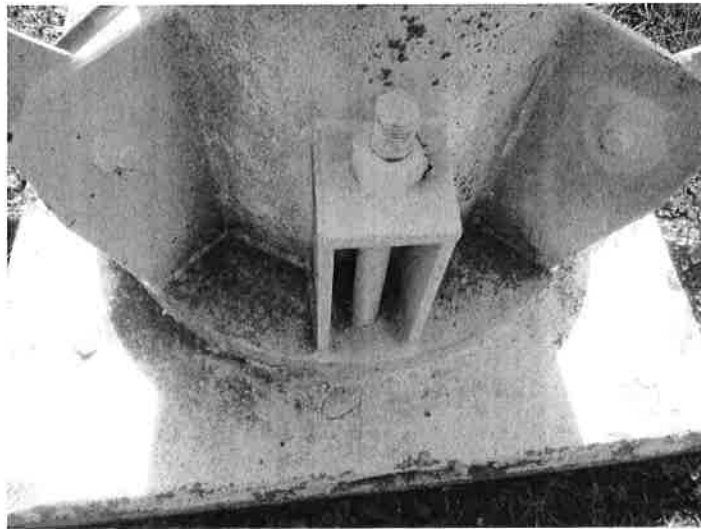
11) The leg anchor bolts are in good condition.

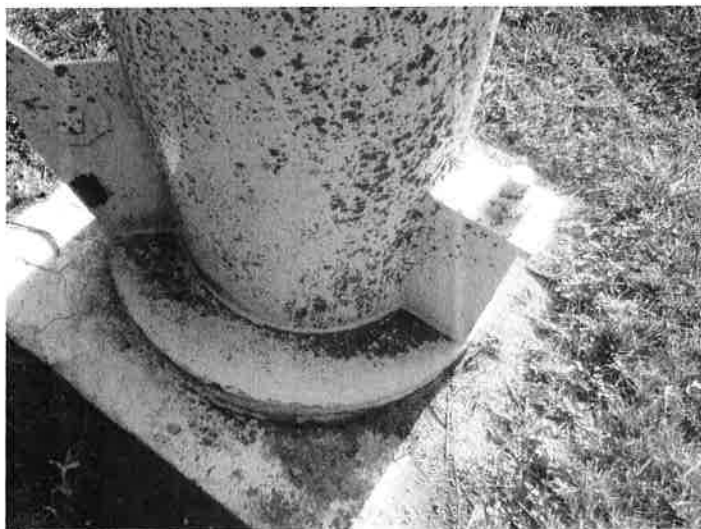
12) There are a few coating failures on the legs.

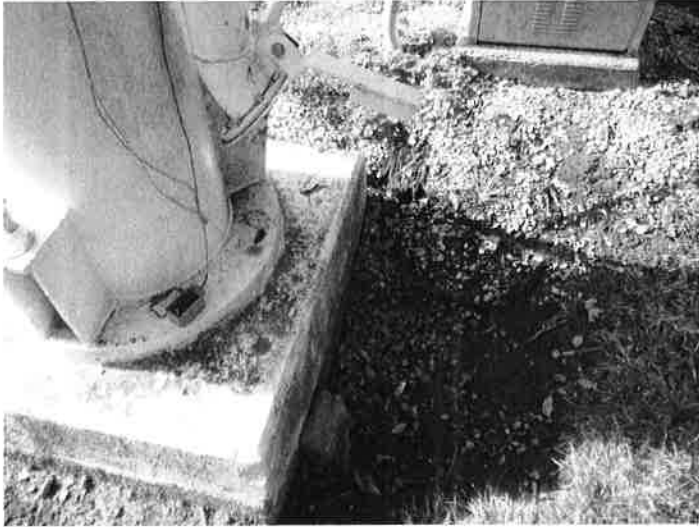
19) The overflow pipe discharges to the ground.

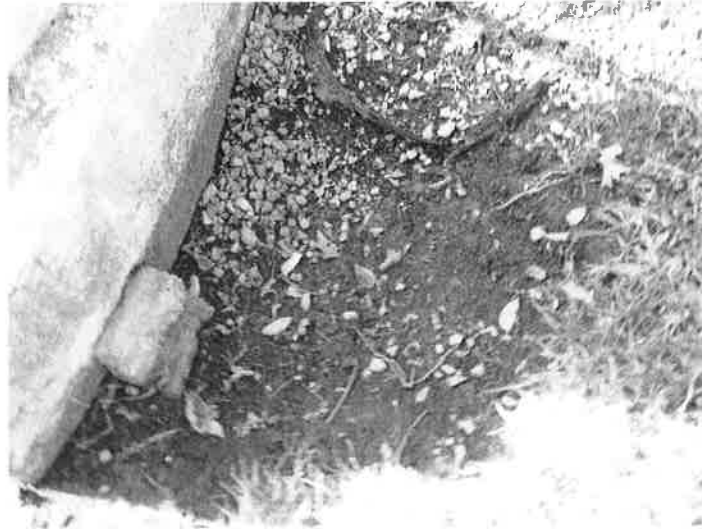
20) There is soil erosion around the leg foundation at the overflow pipe discharge.

3. Backfill soil around the overflow pipe discharge and leg foundation. The work can be performed by in-house personnel.
4. Drill drainage holes in the balcony walkway. The cost would be incidental to exterior painting.

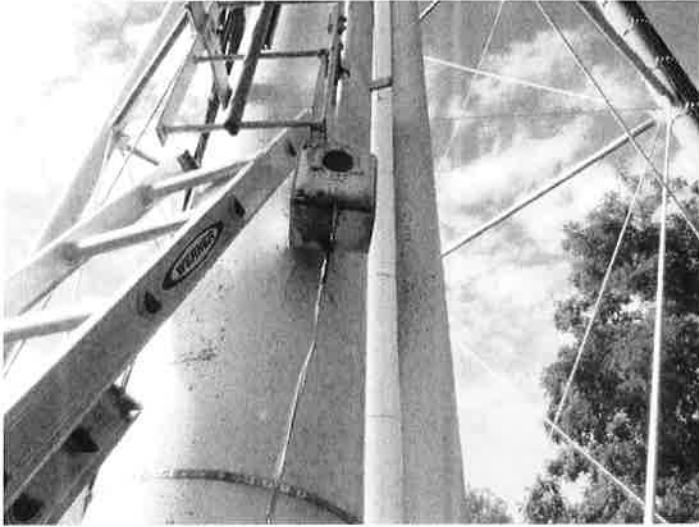
22) The photoelectric cell for the aviation light is mounted on a leg.

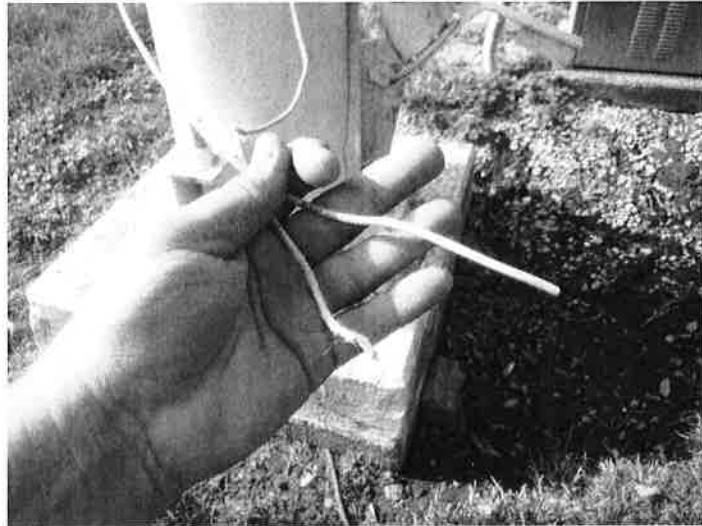
The tank has a double aviation light on the roof that appears to be in good condition. There is a photocell on a leg that will switch the lights on when it is dark outside. It could not be determined if the lights are operational. The photocell wires have been cut.

23) The wires for the photoelectric cell have been cut.

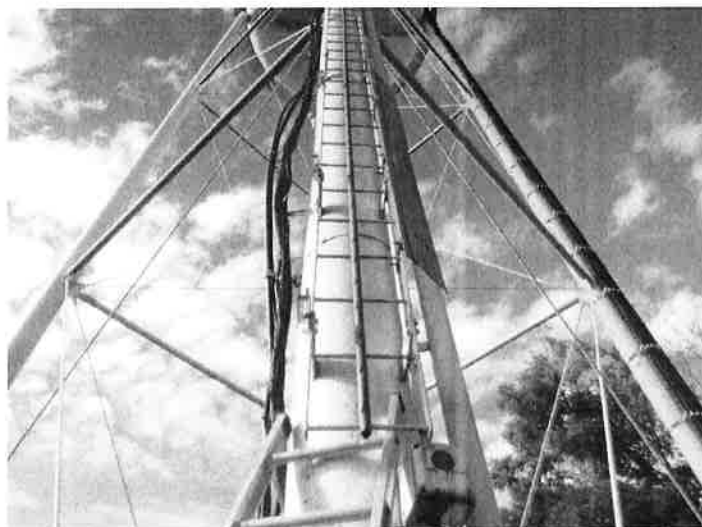
24) There is no vandal guard on the leg ladder.

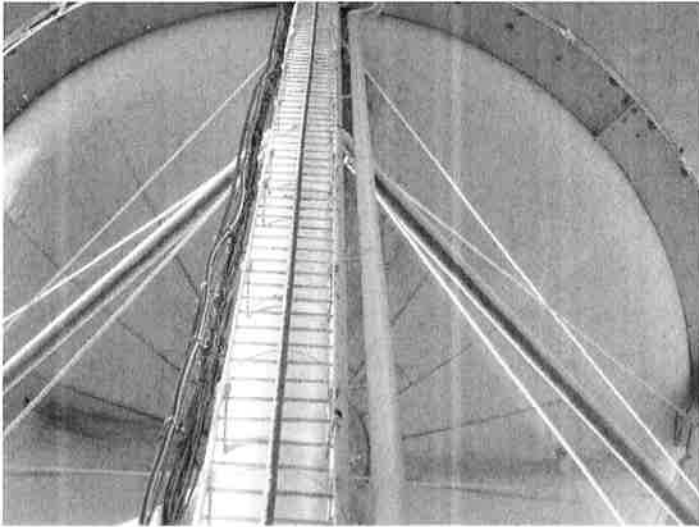
25) The leg ladder is in good condition. The ladder is equipped with a fall prevention device. The top 20 feet of the fall prevention device is install upside down.

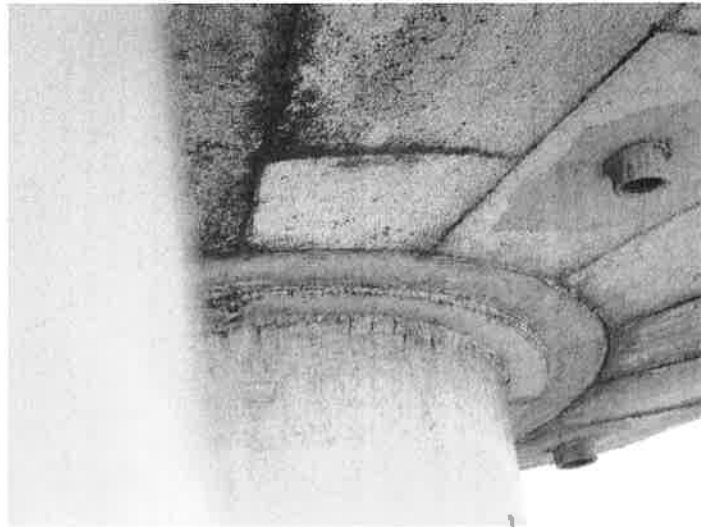
The bowl coating is in good condition with a few failures. Primary methods of deterioration are spot failures to the substrate with rust undercutting and erosion. The bowl is covered with light mildew growth.

26) There are a few coating failures on the bowl.

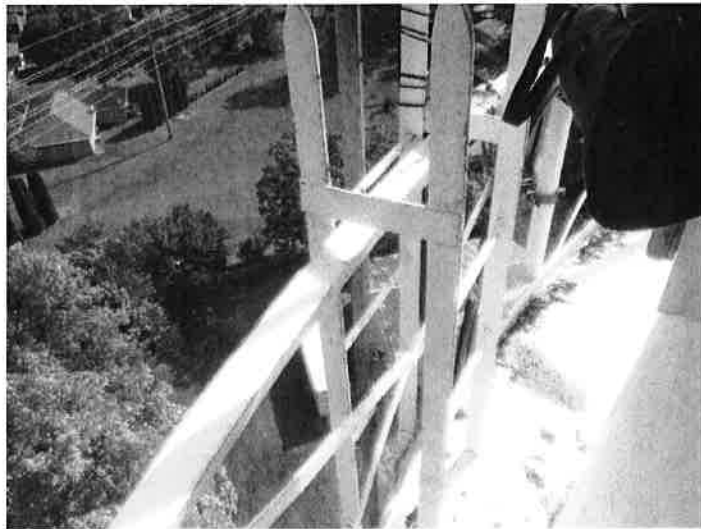
30) There is evidence of water ponding on the balcony.

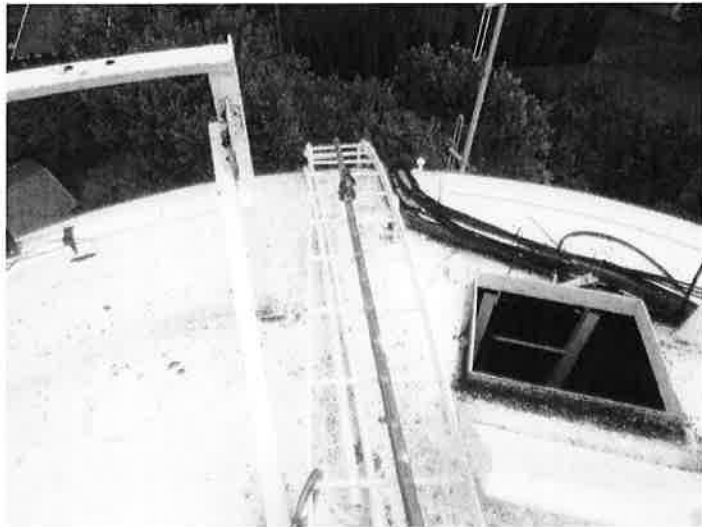
There is a fixed sidewall/roof ladder that follows the curve of the roof to the center near the vent. The ladder is in good condition. The ladder does not meet OSHA size requirements. The ladder is equipped with a rail-type fall prevention device that is in good condition.

38) The sidewall/roof ladder is in good condition. The ladder is equipped with a fall prevention device.

Replace the roof/sidewall ladder with a vertical sidewall ladder that runs up to a step-off platform. The platform would have a handrail that would extend around the roof hatch.

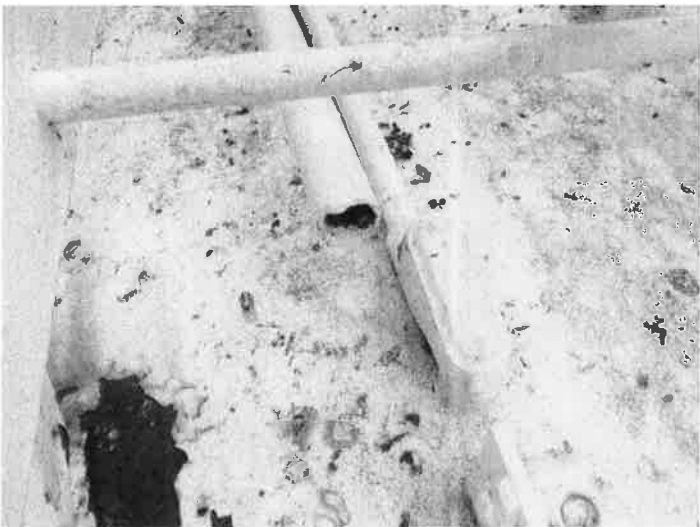
The roof coating is in fair condition with a few failures. Primary methods of deterioration are spot failures to the substrate with rust undercutting, delaminated topcoat, and erosion.

39) There are a few coating failures on the roof.

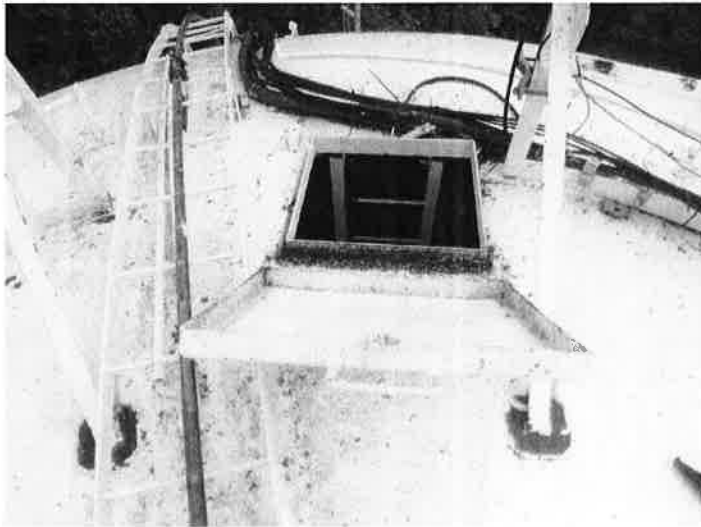
There is a 24 inch square roof hatch to the wet interior that is in good condition. The hinged cover is in good condition. There is no handhold next to the hatch to aid the climber while entering and exiting the opening. The hatch was not secured. The hatch neck curb height does not meet the minimum height requirement of 4 inches. The hatch cover lip meets the minimum height requirement of 2 inches. There was no gasket on the hatch. Dixon attempted to install a gasket, but the cover would not close with the gasket installed.

46) There is no gasket on the wet interior roof hatch. Dixon attempted to install a gasket, but the cover would not close with the gasket installed.

Replace the wet interior roof hatch with a 30 inch hatch that has a curb that is 4 inches tall, has a 2 inch lip, and install a gasket on the curb to meet current IDEM requirements. The estimated cost is \$4,000.

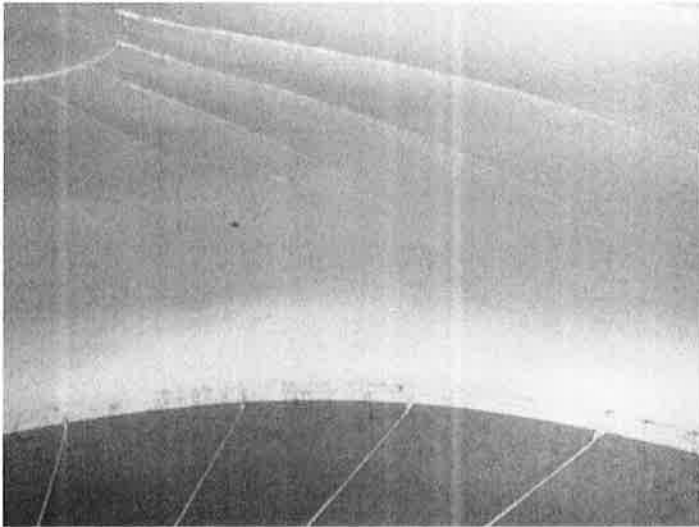
The roof coating is in good condition with just a few failures. Primary methods of deterioration are spot failures to the substrate with rust undercutting and rust bleedthrough. There are minor coating failures on the roof panels but most of deterioration is along the lap seams and at the roof rigging couplings. The roof contains lap seams that have started to corrode and there is rust streaking. The presence of corrosion in the lap seams is not a concern but should be monitored during future inspections for additional corrosion growth.

52) There are a few coating failures at the lap seams and rigging couplings on the wet interior roof.

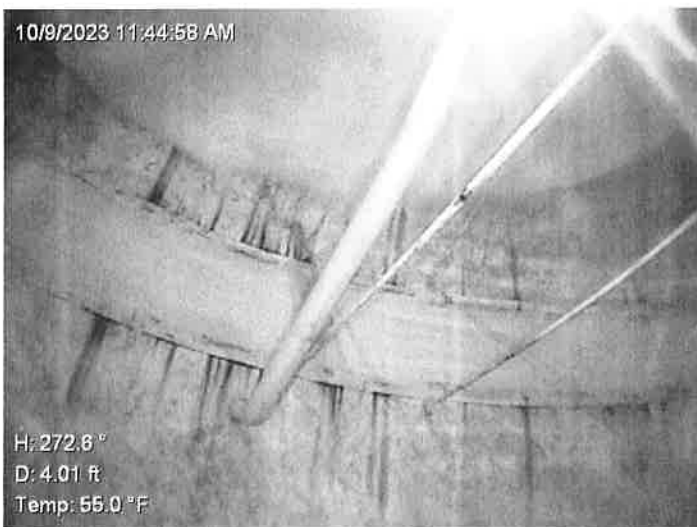
The sidewall coating is in fair condition with a few failures. Primary methods of deterioration are spot failures to the substrate and rust bleedthrough. Most of the coating failures are at the spider rod connections. There is no significant coating damage at the high-water level which would be the area most affected by ice movement.

57) There are a few coating failures on the wet interior sidewall.

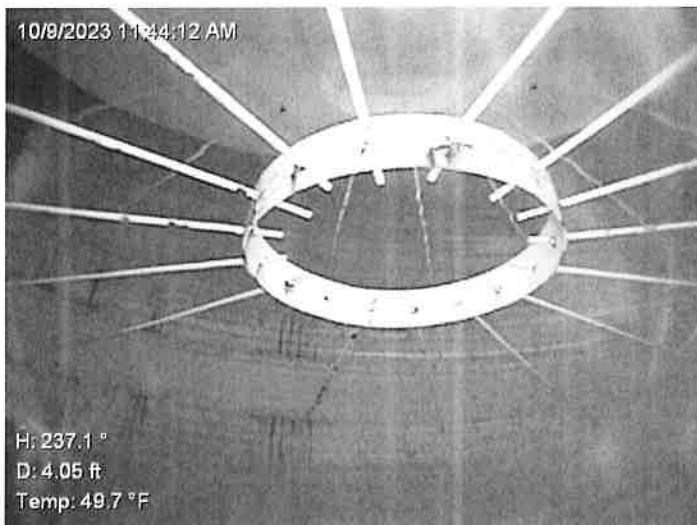
63) There are coating failures on the spider rods and bull ring.

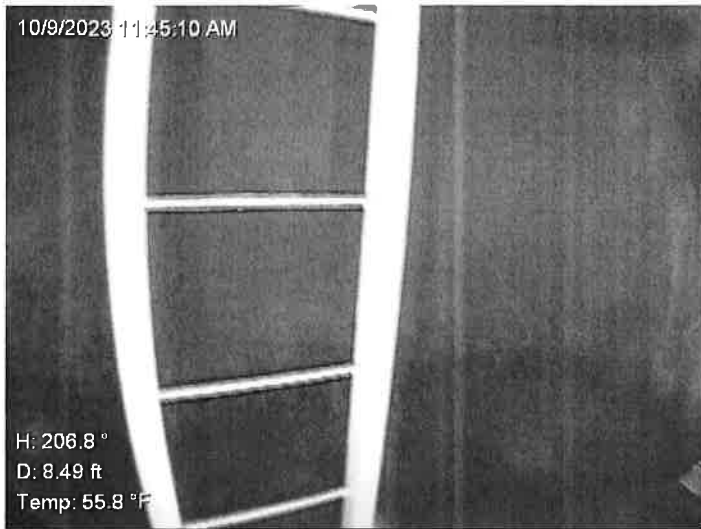
There is a wet interior ladder from the roof to the bowl that appears to be in good condition. The ladder does not meet OSHA size requirements. The ladder is not equipped with a fall prevention device that was not used during the ROV inspection.

64) The wet interior ladder appears to be in good condition. The ladder is not equipped with a fall prevention device.

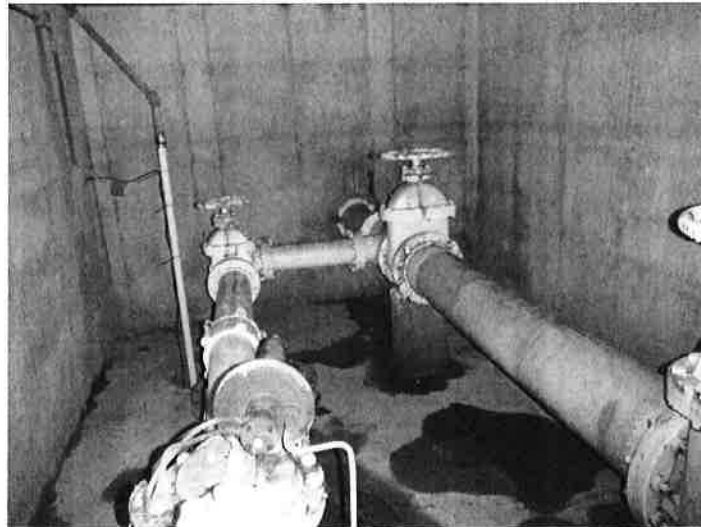
There is a pit adjacent to the tank that contains piping and valves. The pit has a metal hatch that is in good condition. The piping is in good condition. The coating on the piping is in fair condition with general surface corrosion.

68) There is general surface corrosion on the pit piping.
