**HEBRON TOWN COUNCIL
HEBRON UTILITY REGULATORY COMMISSION
MINUTES OF JANUARY 23, 2024**

On October 9, 2023, Dixon Engineering Inc. performed a maintenance inspection on the 100,000 gallon double ellipse (South) elevated water storage tank owned by the Town of Hebron, Indiana. Purposes of the inspection were to evaluate the interior and exterior coating's performance and life expectancy, assess the condition of metal surfaces and appurtenances, review safety and health aspects, and make budgetary recommendations for continued maintenance of the tank. The inspection was performed from existing ladders and platforms with no special rigging and no disassembly of any items was conducted by the inspector. All recommendations with budgeting estimates for repairs are incorporated in this report.

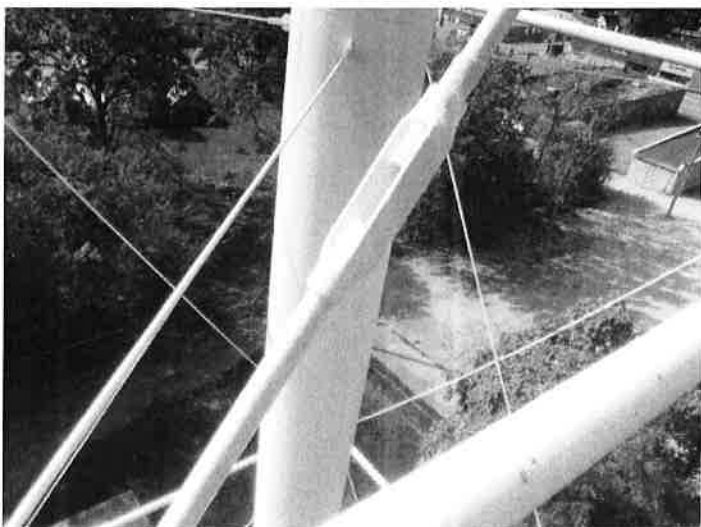
17) There are a few coating failures on the struts.

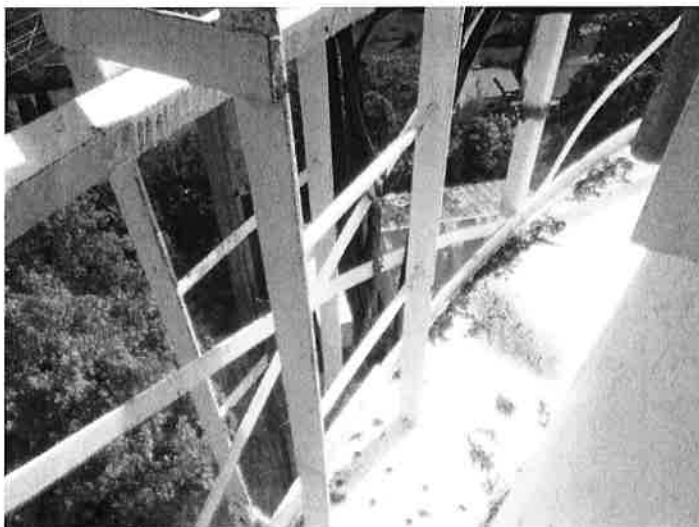
29) There is no opening in the balcony railing at the top of the leg ladder.

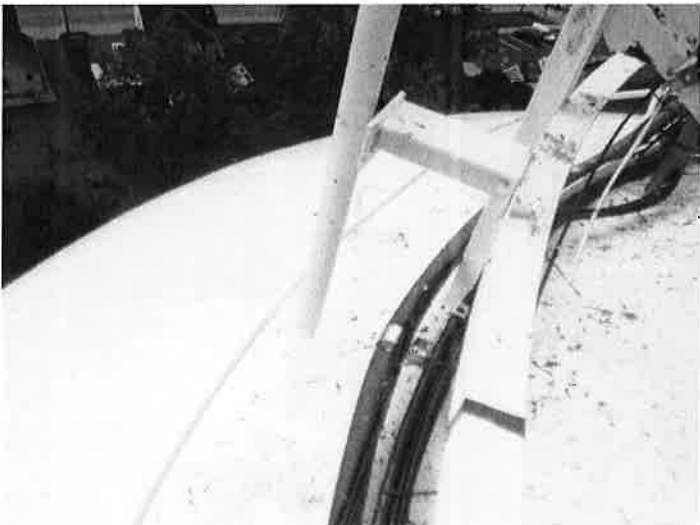
39) There are a few coating failures on the roof.

40) Same.

41) Same.

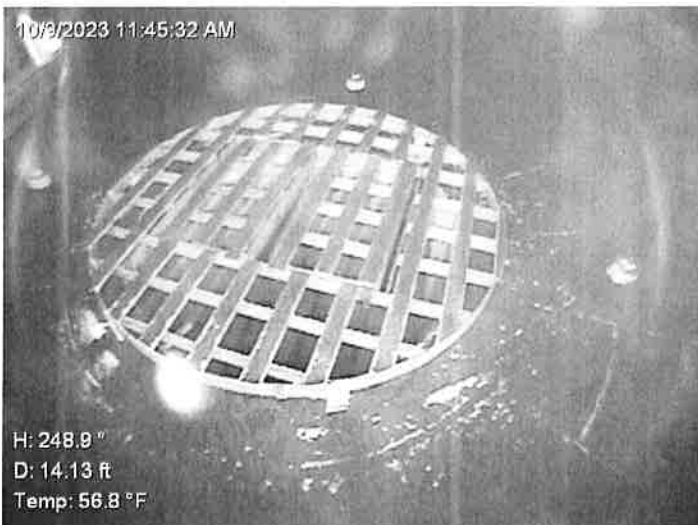
65) The bowl is covered with sediment that limited the amount of surface visible with the ROV.
