**HEBRON TOWN COUNCIL
HEBRON UTILITY REGULATORY COMMISSION
MINUTES OF JANUARY 23, 2024**

On October 9, 2023, Dixon Engineering Inc. performed a maintenance inspection on the 100,000 gallon double ellipse (South) elevated water storage tank owned by the Town of Hebron, Indiana. Purposes of the inspection were to evaluate the interior and exterior coating's performance and life expectancy, assess the condition of metal surfaces and appurtenances, review safety and health aspects, and make budgetary recommendations for continued maintenance of the tank. The inspection was performed from existing ladders and platforms with no special rigging and no disassembly of any items was conducted by the inspector. All recommendations with budgeting estimates for repairs are incorporated in this report.

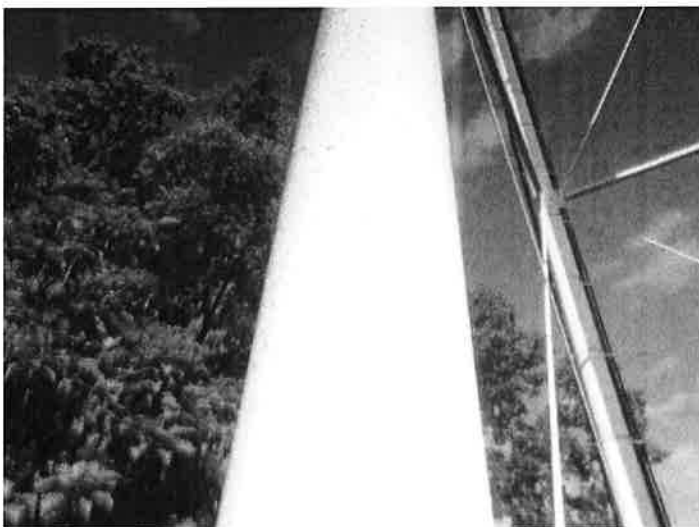
14) The leg coating is in fair condition overall.

15) Same.

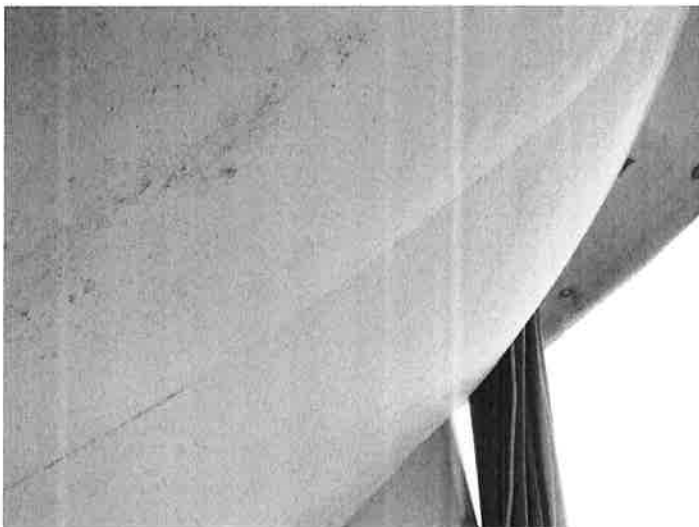
26) There are a few coating failures on the bowl.

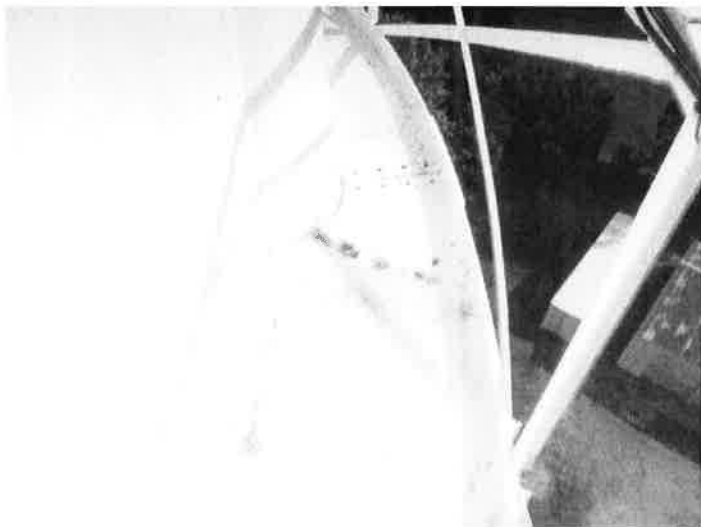
31) The balcony coating is in good condition overall with areas of minor erosion.

32) Same.

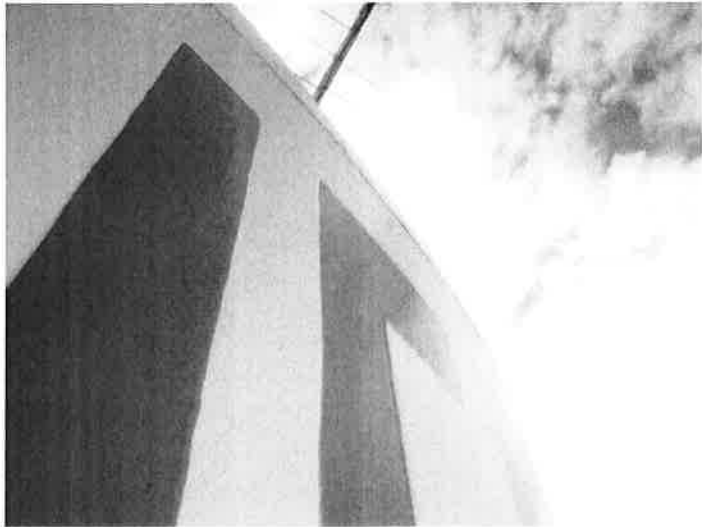
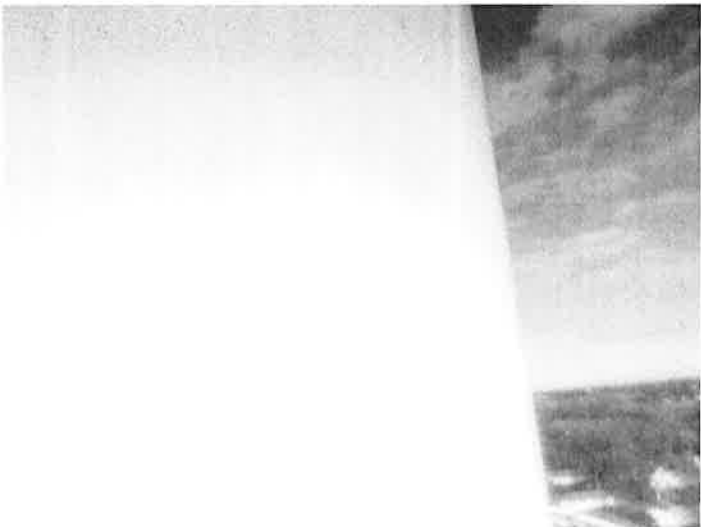
34) The sidewall coating is in good condition overall with a few areas of minor erosion.

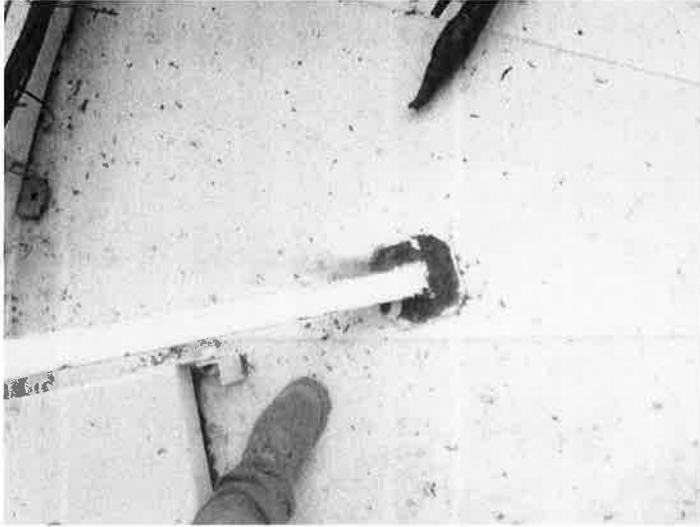
39) There are a few coating failures on the roof.

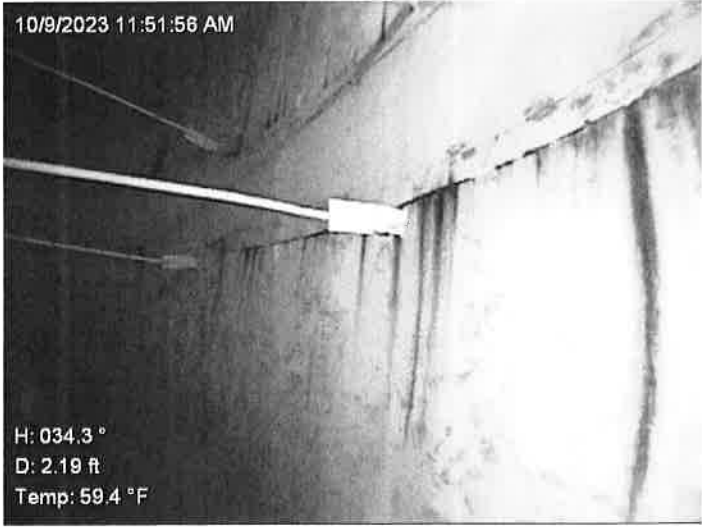
57) There are a few coating failures on the wet interior sidewall.

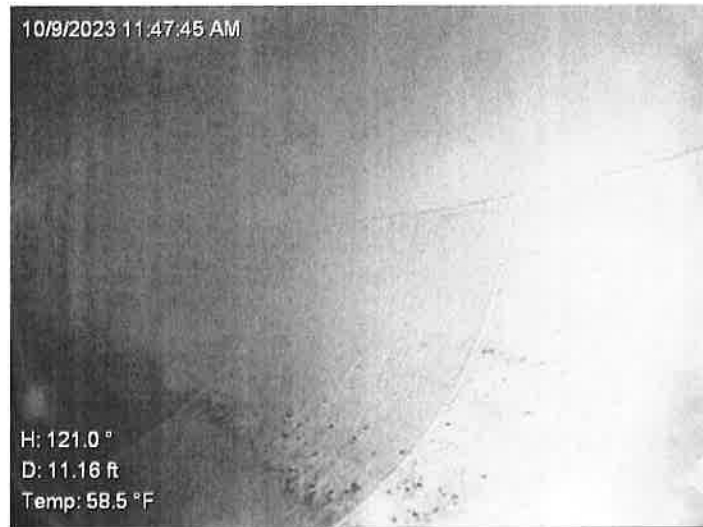
61) The wet interior sidewall coating is in fair condition overall.
